A proposal for the Dielectric Evaluation of the Condition of Composite Insulators

- Initial Experiences

J.M. Seifert, S. Bhattacharyya, J. Lambrecht,
TKE Beratungsgesellschaft mbH,
F. Lehretz, TenneT TSO GmbH

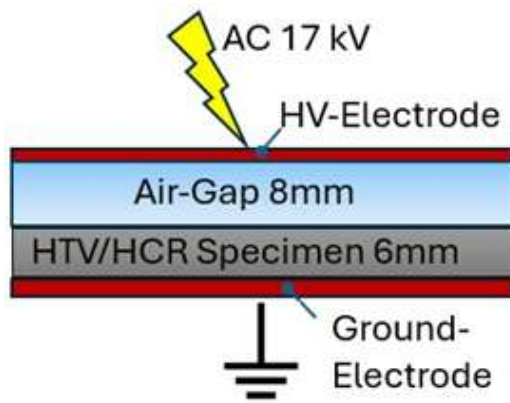
Duration of treatment:
1h, 10h, 100 h

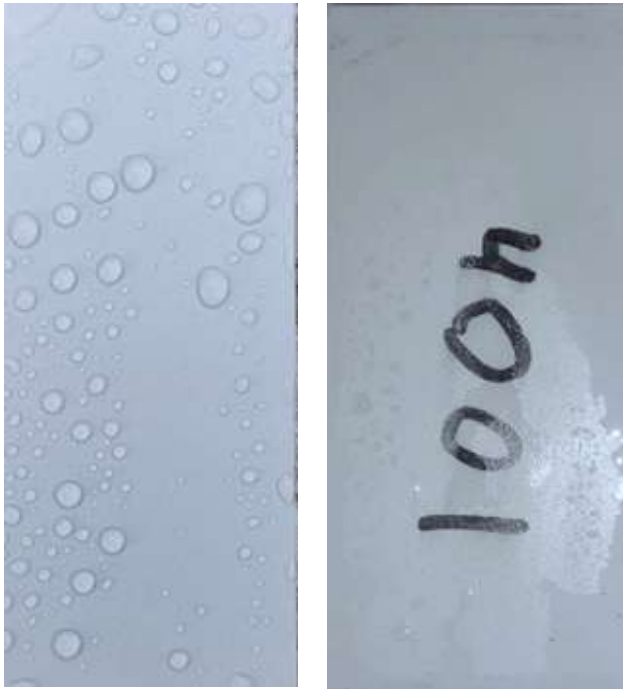
O_3 and nitric acid are generated as by-products of the corona process in air.

Treatment leads to a loss of the hydrophobicity (as expected) due to deposition of charges, a loss of CH_3 -groups of the PDMS-structure accompanied with surface oxidation ($-CH_3 \rightarrow -OH$).

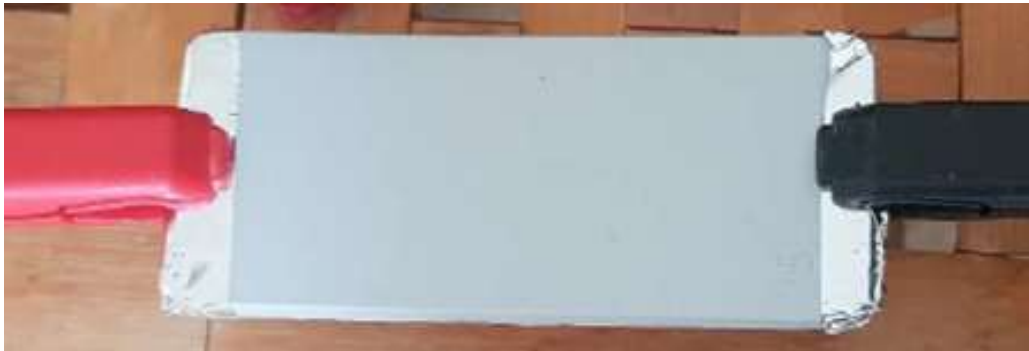
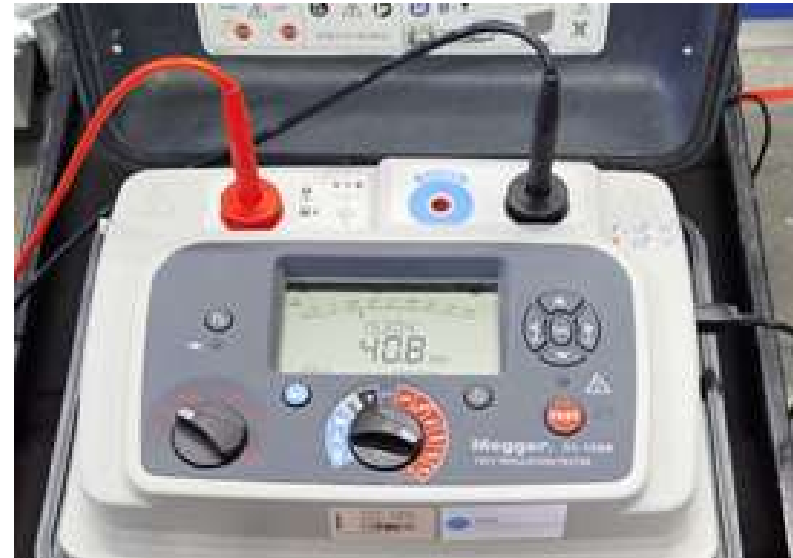
After the treatment a current response measurement was performed.

Megger S1-1568® testing device was used in the IR(t)-mode with an application of a step voltage of +15 kV DC.

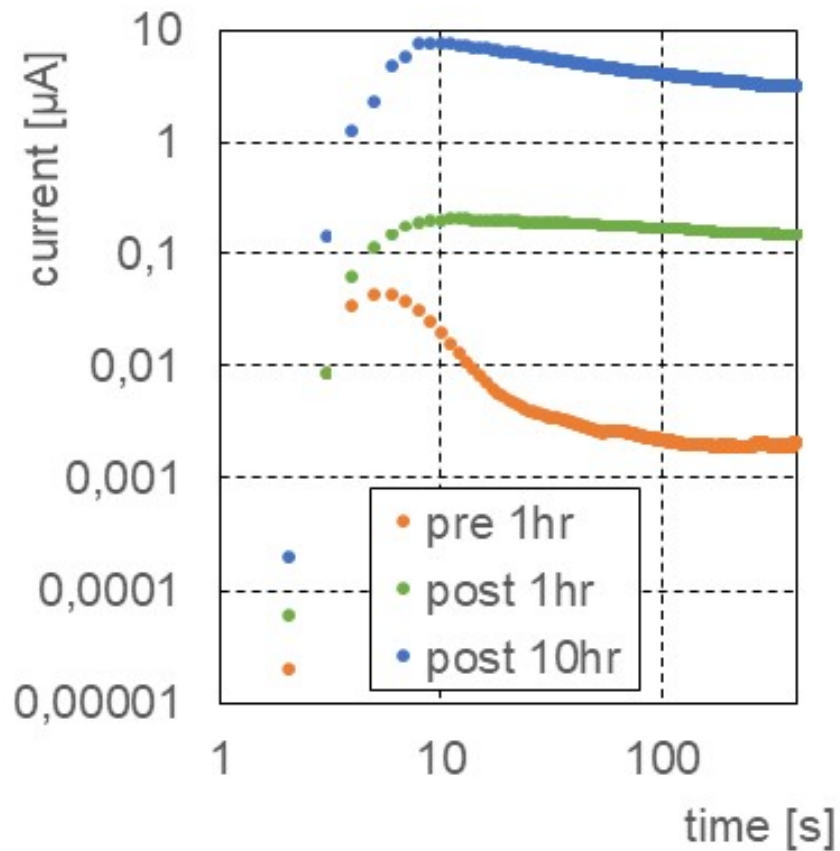
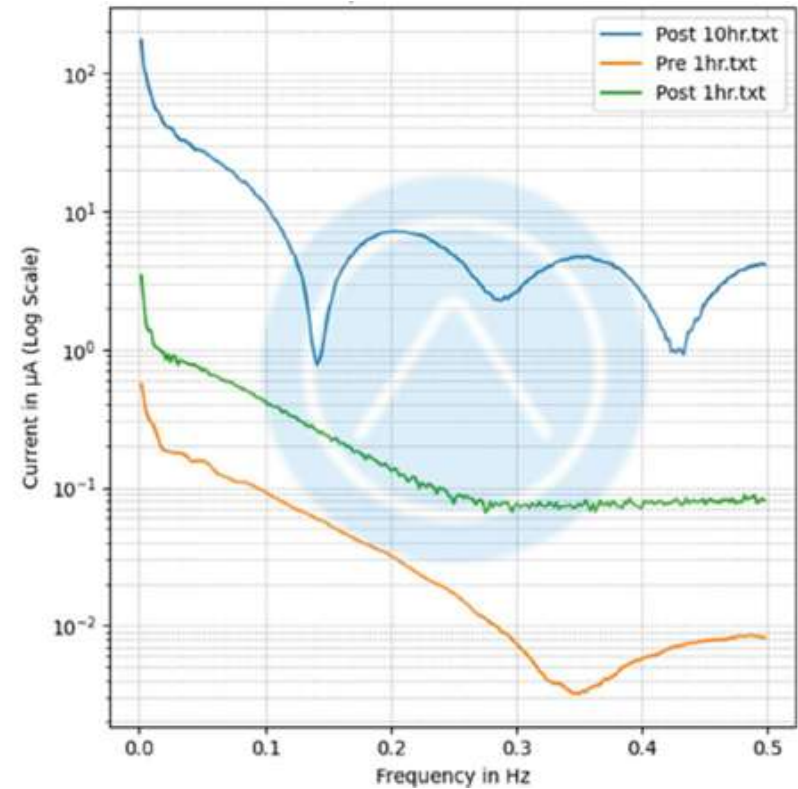
- Longer treatments (100 h) don't lead to further increase of the current,
- The effect may be explained by surface charging with a saturation after all charge acceptors in the material are filled up with charge carriers.
- A repetition after 48 days leads to the same results,
- While the hydrophobicity is recovered within 48 hours, the current response signal remains increased for long durations.
- This means that a longer lasting material modification was initiated by the corona discharges.

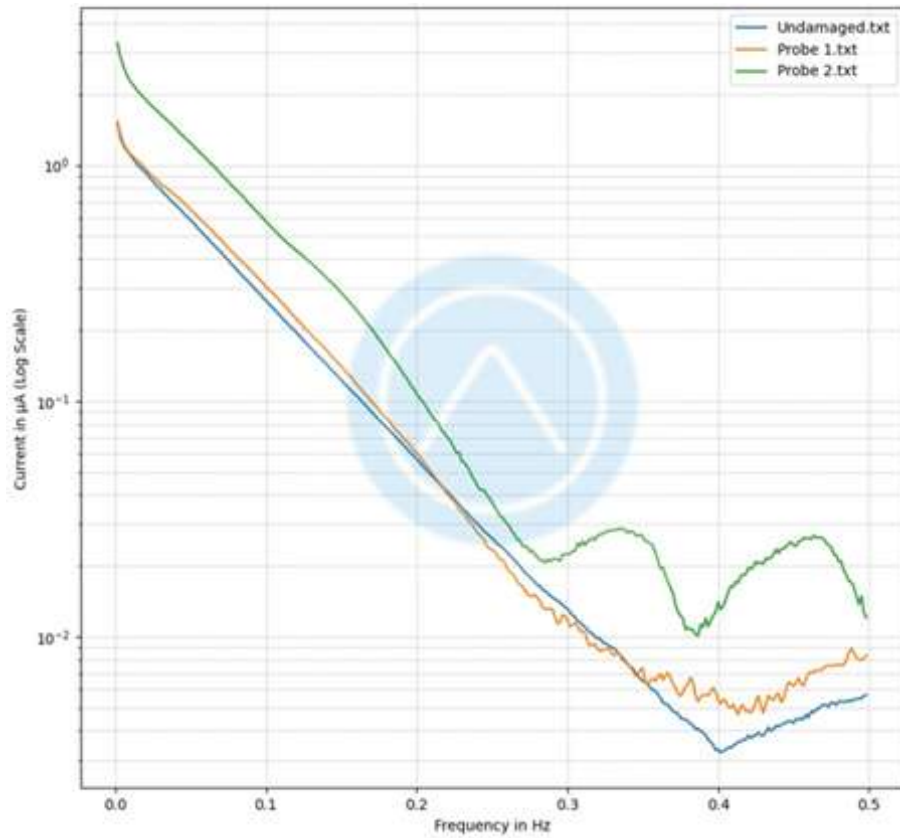
Green: Severe Degradation
Orange: beginning degradation
Blue: new insulator

Sample	Condition
A	Sound (new) composite insulator from production line, no defects (blue)
B	Sample in beginning phase of decay-like fracture (orange)
C	Sample with severe interfacial degradation/ decay-like fracture (green)

Sample C: DD > 2
Sample B: DD = 1-2
Sample A: DD < 1
